# How to rehabilitate the identity of a building by means of zinc roofing

SYSTEM Arquitectos have refurbished the 1963 Intelhorce industrial textile warehouse

The intervention focuses on the structural rehabilitation and the restitution of the envelope

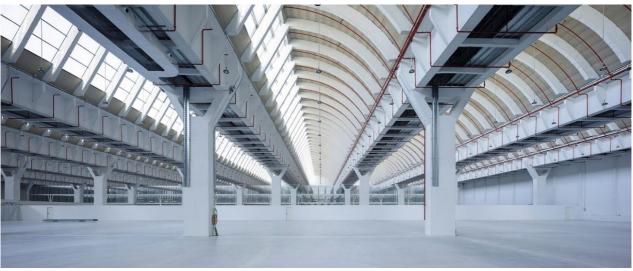
Roof detail.

The building also seeks energy optimisation through refurbishment. Its location, in Malaga, is a challenge due to the high solar incidence and the roof, must dissipate these heat gains and provide adequate insulation to prevent heat loss from HVAC systems. elZinc's natural zinc offers good reflectance which prevents heat build-up within the roof; the zinc sheet, installed with a standing seam, is laid over a waterproofing membrane and sits on top of panels which provide the required amount of thermal insulation.

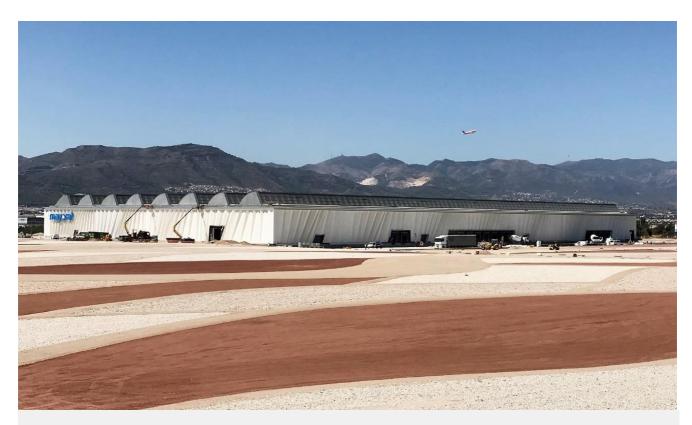
The materiality of zinc as a roof cladding fits in perfectly with the original design of the factory.

The roof is an identifying element of this industrial building. Designed with a saw-tooth profile, its preservation is essential to restore the morphology and aesthetics of the building. To this end, a double strategy has been chosen in which the geometry of the pre-existing structure, whose presence is the protagonist of the project, is maintained, offering the possibility of choosing the ideal colour tone.
